Skýrsla nr. 2023-022

Fecal bacteria concentration around Veitur's WWTPs in Borgarbyggð

**Report on fecal bacteria samples from Bifröst, Varmaland,
Reykholt and Hvanneyri**

Veitur

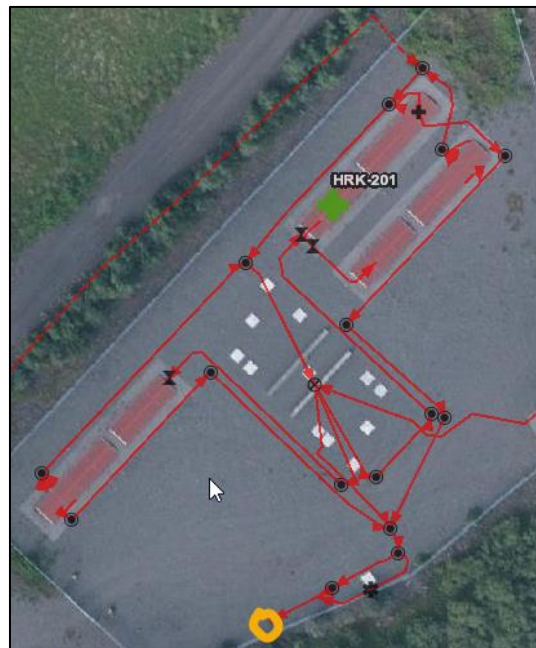
Figure 2 Sampling locations at Bifröst

The samples from 27/09/2022 till 15/11/2023 were taken after the treatment where the effluent from the treatment plant enters the environment at the location marked with an orange circle shown in the figure below number 2. The effluent is discharged into the porous lava via an infiltration pit.

Bifröst results fluctuate more than is acceptable and have shown results with 5 samples out of 28 exceeding the limit value. There is a need for future investigation for a more appropriate sampling location. Now, the sample is taken in front of an infiltration soakaway, and that does not reflect the possible risk. There were two samples taken in the pond just below the infiltration soakaway at Bifröst in September and October 2023. Originally, the samples were also supposed to be taken from two ponds, but as it turned out, the pond on the left was just an old lava field and not a pond. Because the treatment plant has a higher elevation, it was expected to find some signs/remains of indicator bacteria in the samples if they are able to survive the underground journey at all. The results can be seen in the table below.

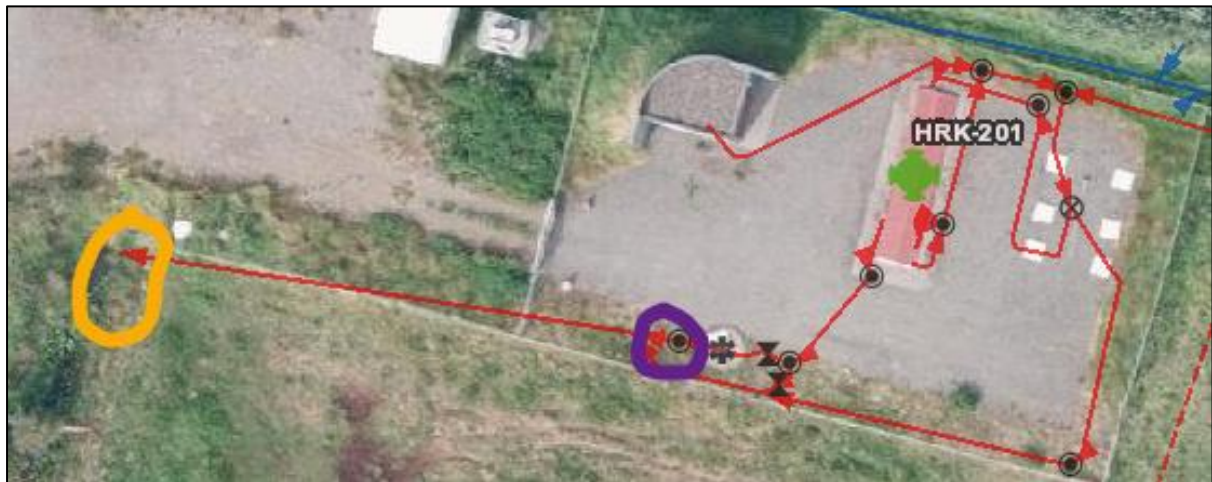
Figure 3 Sampling locations at Varmaland

All samples from 27/09/2022 until July 2023, were taken in the manhole marked with a purple circle. The location was changed in July 2023 and the sample is taken in a swale outside of the

fenced area of the treatment plant, where the public can get in contact with the effluent. The actual sampling location is marked with an orange circle.

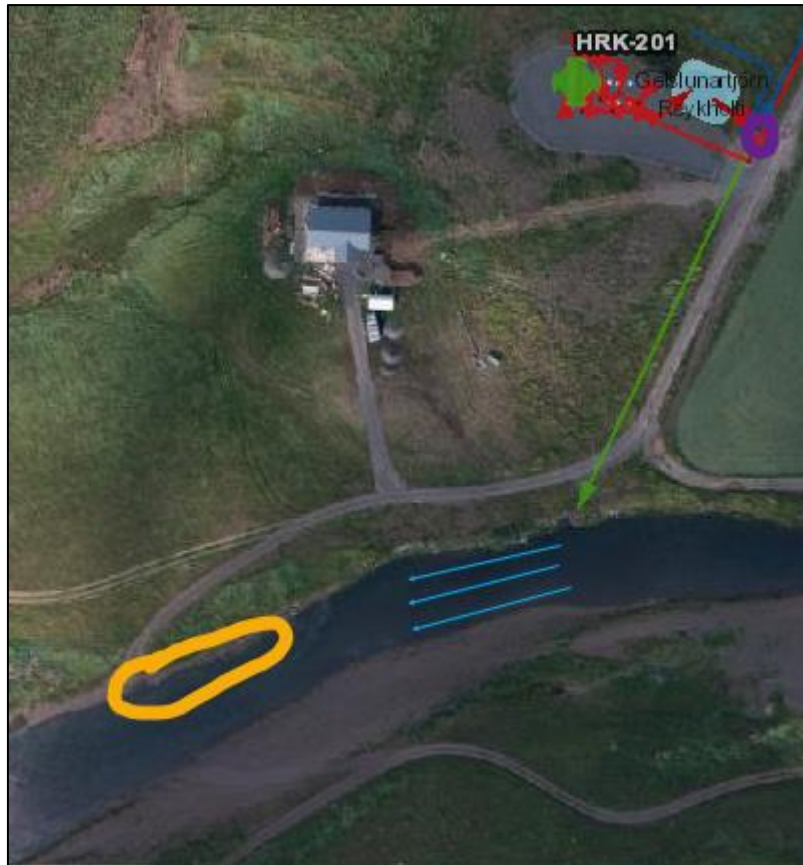
Figure 4 Sampling locations at Reykholt

Originally, the sample was taken right after the treatment plant before the effluent was discharged into the river. It is marked with a purple circle in the picture, but this sampling location is not accessible to the public. The sampling location was changed in April 2023 so the sample would be taken from water which the public might encounter. The sample is taken downstream, in the river, where the effluent is being discharged and diluted with the water.

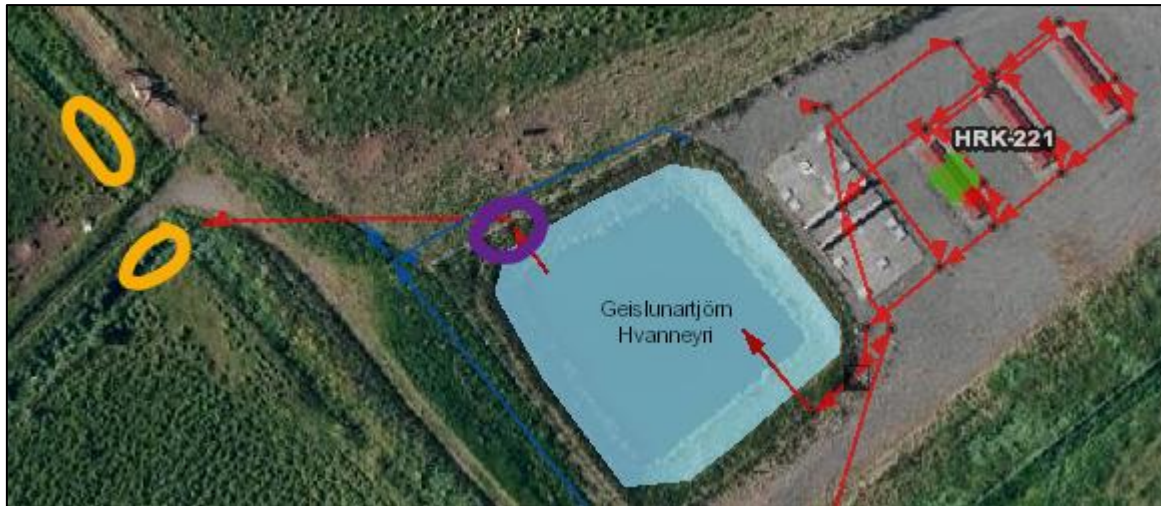
Figure 5 Sampling locations at Hvanneyri

At Hvanneyri, at the beginning the sampling was done inside the area of treatment plant which did not reflect the true impact on the environment and health risk to the public, because the sampling location was not accessible to the public. Same as in Reykholt, it was decided to take the samples a bit further from the UV pond. There were 2 samples taken in the swales close to the discharge point of influent for each sampling period. The purple mark in the figure below shows the original location of sampling and the orange circle marks the latest sampling locations.

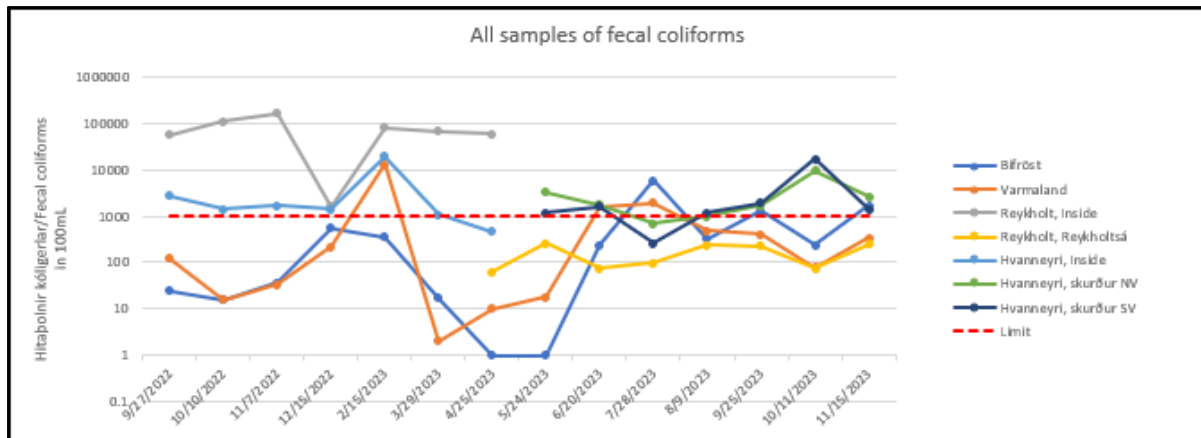
Figure 6 Graph of fecal coliforms values

For fecal coliforms (hitapólnir kólígerlar), out of 50 results, 32 were under the limit value and 18 had a higher count of bacteria than the limit. That makes a 64% success rate. However, 12 out of the 18 non-compliant results were taken at Hvanneyri. The graph below shows the number of fecal coliforms at all the testing areas and how they changed throughout the testing period.

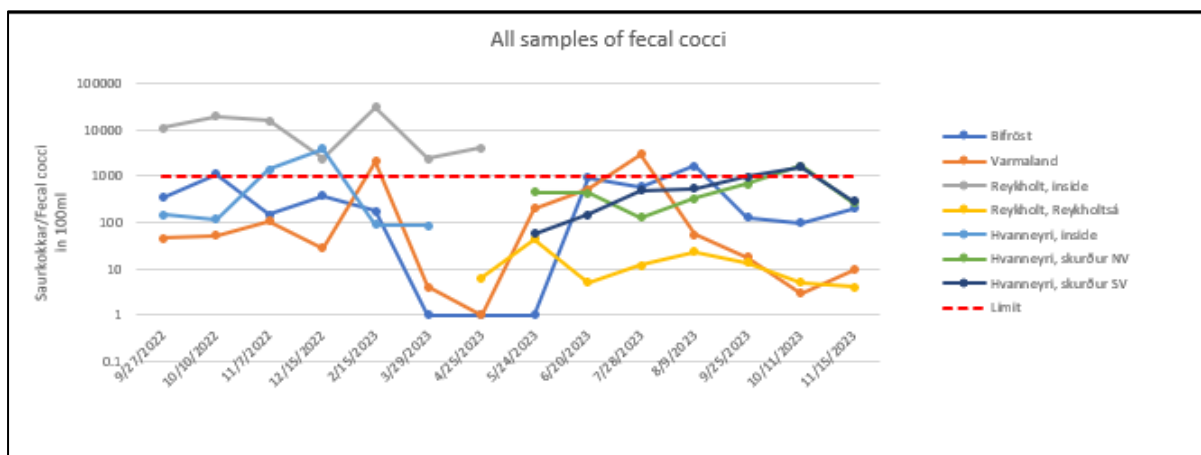
Figure 7 Graph of fecal cocci values

Fecal cocci had a better success rate of 88%. 44 out of 50 samples had a lower number of bacteria than 1000 and only 6 exceeded the limit. It all can be seen in the graph below.

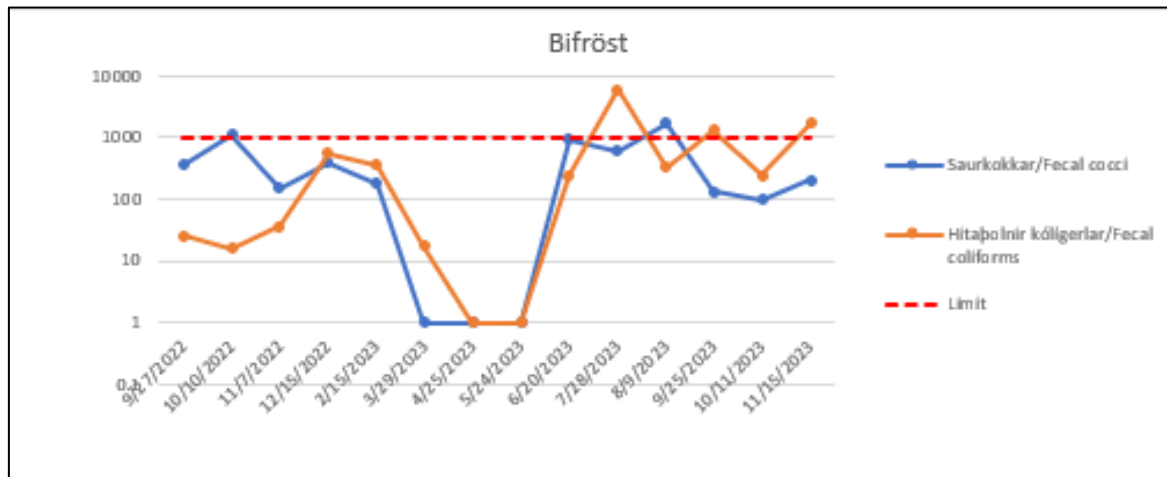
Figure 8 Results of samples taken at Bifröst

Bifröst came out with mostly positive results. For the fecal coliforms there were 3 samples where the total count of bacteria exceeded the limit value of 1000. For the fecal cocci, there were 2 samples that exceeded the limit value.

The average amount of bacteria in one sample came out to be at 757.57 for fecal coliforms and 415.07 for fecal cocci. Both average values are below the limit value. The exact values can be seen in the table 3 below.

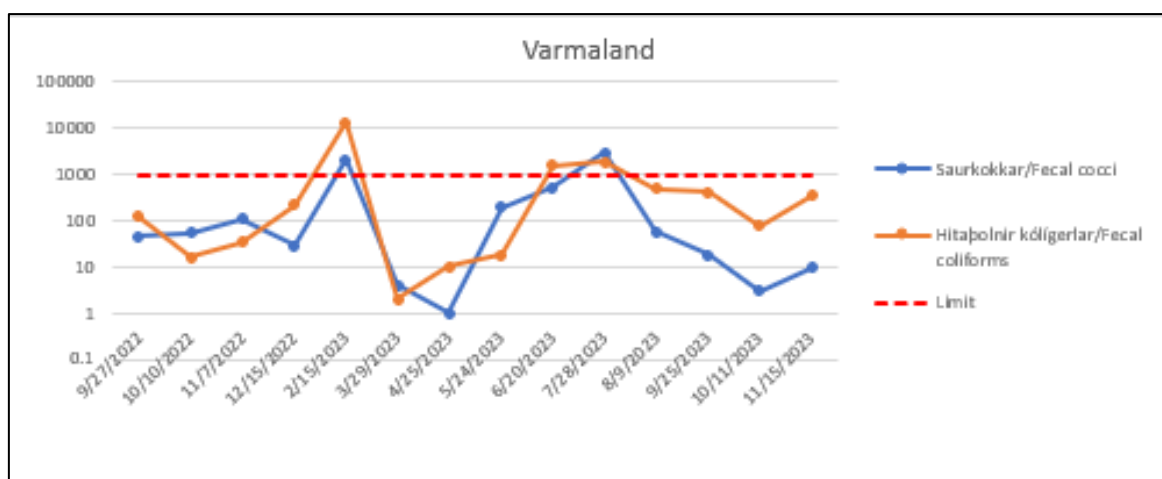
Figure 9 Results of samples taken at Varmaland

The samples at Varmaland came up with 3 samples exceeding the limit value for fecal coliforms and 2 samples for fecal cocci. Sample taken 15/02/2023 showed an unacceptably high value of 13000 bacteria per 100mL for a fecal coliform.

The average value at Varmaland for fecal coliforms was calculated to be 1302.79 which is over the limit and for fecal cocci it was 439.20 which is a safe value. Values are shown in the figure below.

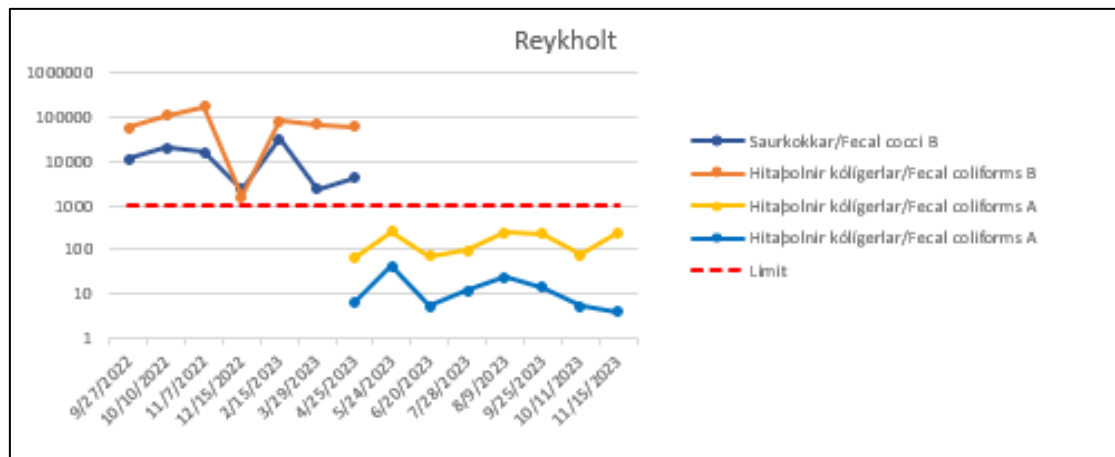
Figure 10 Results of samples taken at Reykholt

From 27/09/2022 until 25/04/2023 all the results from the sampling came out to be highly over the limit for fecal coliforms and fecal cocci. Those results are from a sampling site not accessible to the public. Since the change of the sampling location in April 2023, none of the results showed a value higher than the limit. In fact, all of them were under the limit value set by the Veitur of 500 units/mL for both fecal coliforms and fecal cocci.

The average for Reykholt's old sampling location came up to be 78.800 units for fecal coliforms and 12.414,29 units for fecal cocci per 100mL. The average at a new sampling location is 161,25 units of fecal coliforms and 14,38 units for fecal cocci. All the values are shown in the table below.

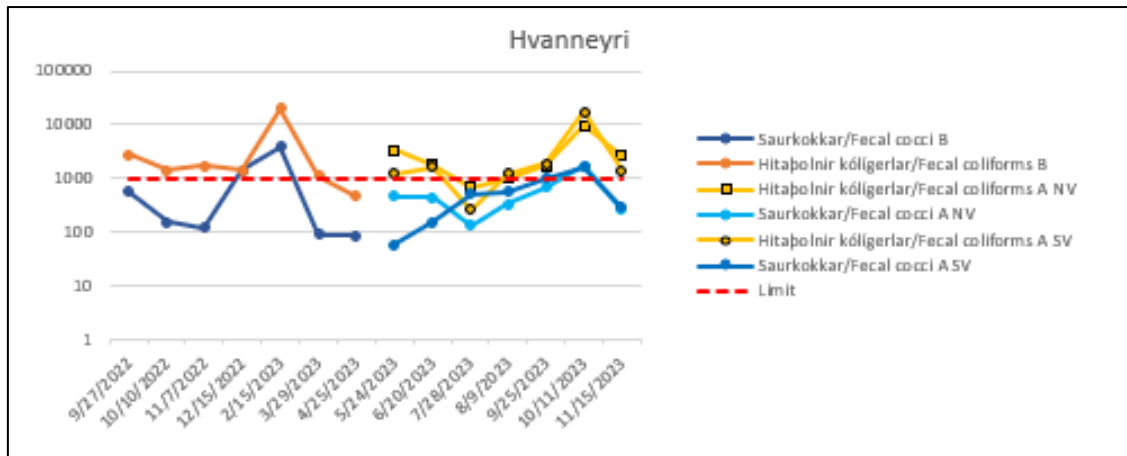
Figure 11 Results of samples taken at Hvanneyri

Fecal coliforms total count per sample was almost always higher than the limit set by the Icelandic Ministry of the Environment, Energy and Climate even after changing the location from within the fenced area to the swales next to the discharge outfall. In the case of fecal cocci, the results were usually below the limit except for 4 samples, and two of them happened at the old sampling location. Since the location was changed, there were two values exceeding the limit of 1000 units per 100mL.

The average for fecal coliforms in the old sampling location was 4122,86. For the new location at north it was 2984,29 and at south 3508,57 units per 100MI.

Average for fecal cocci in the old location and new ones is below 1000. The old location's average is 899,43. At north it is 571,43 and at south it is 589,71.

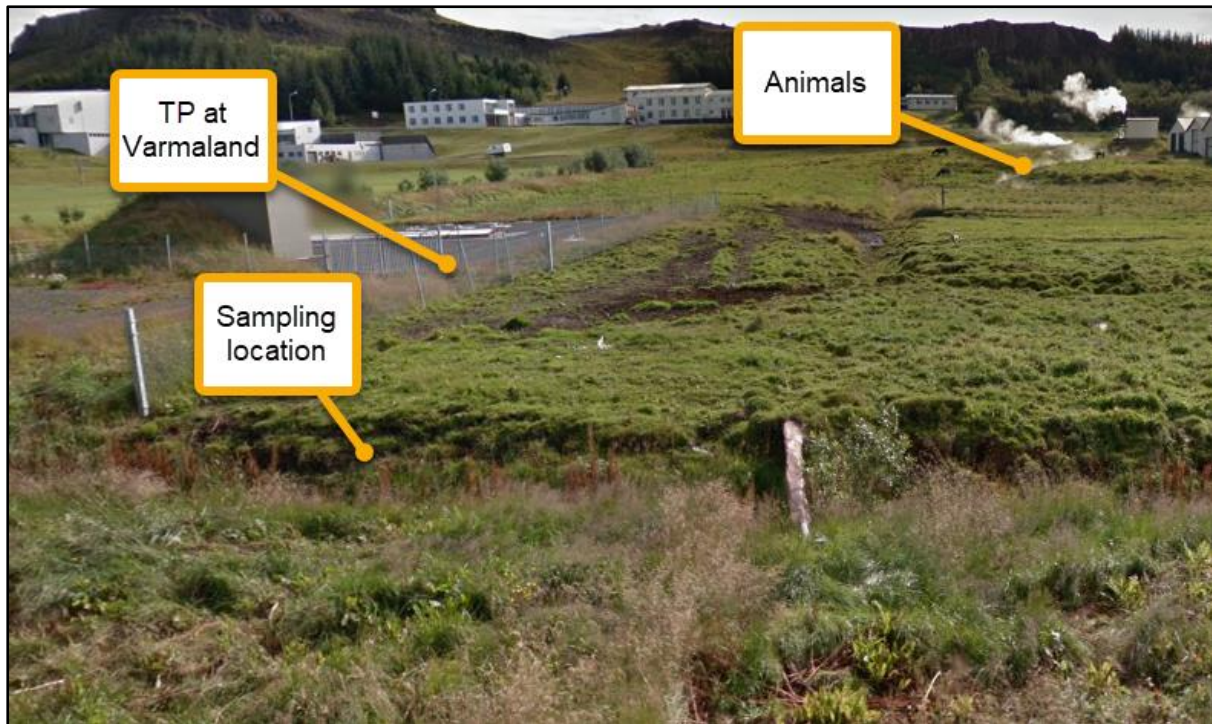
Figure 13 Varmaland sampling location

Varmaland's results were similar to those at Bifröst, with 5 samples exceeding the limit values out of 28. There is a camping site to the north of the treatment plant, and therefore the health risk is high. In addition to the load from the effluent, animals in neighboring grazing grounds might contribute to the bacteria concentration in the swale close to Veitur's discharge location.

Rain could be one of the ways of how the bacteria travels/transport from fields where the animals are to the swale. In figure number 13, the swale where the sample is taken is probably around 80 centimetres deep, so it could mean that the rain infiltrates to the ground and gets naturally directed to the swale because of the elevation. A small illustration of the process can be seen in figure 14 below, where the area, elevation, and possible water direction are highlighted.

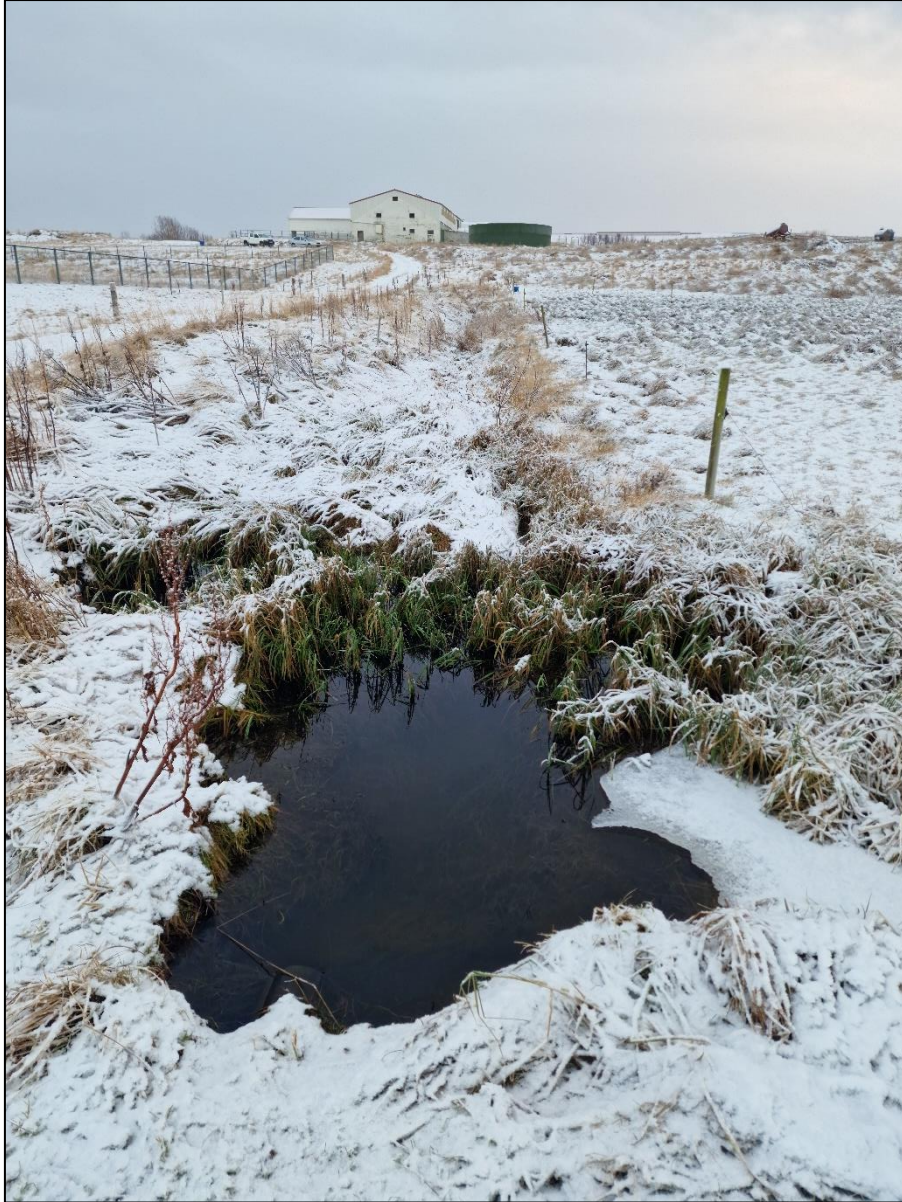
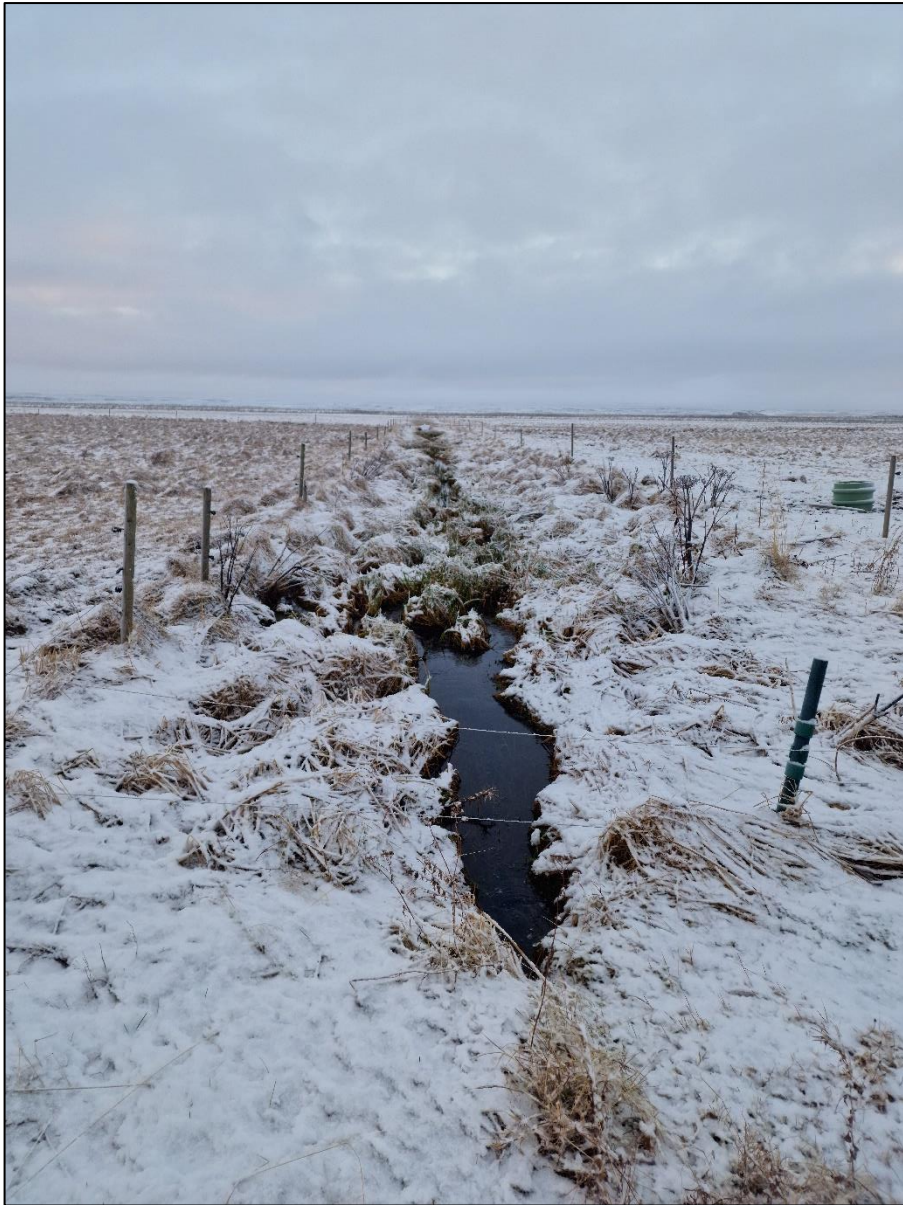
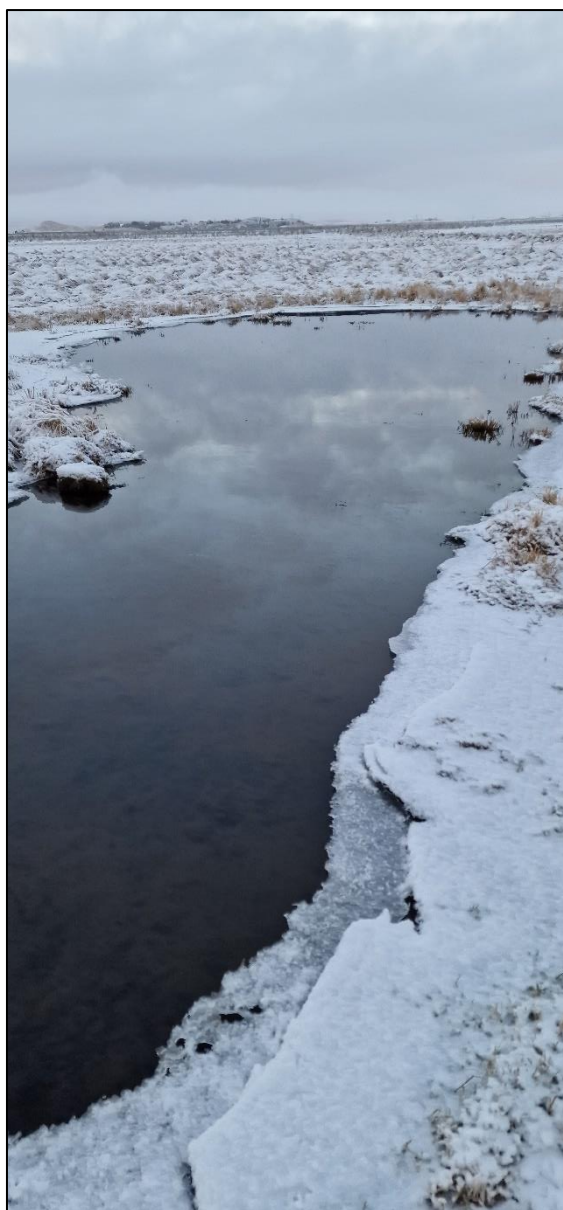
In addition to the effluent from Veitur, a neighboring dairy production farm could be a source of the bacteria. The Agricultural University of Iceland has an animal stall located close to the sampling location. Veitur does not receive any wastewater from them, so it is assumed that the wastewater from the animal stall is treated and released into the environment locally.
